# Teretek® Re-levels Heritage Café in Melbourne

Café

Soil Subsidence

Berwick, VIC, Australia

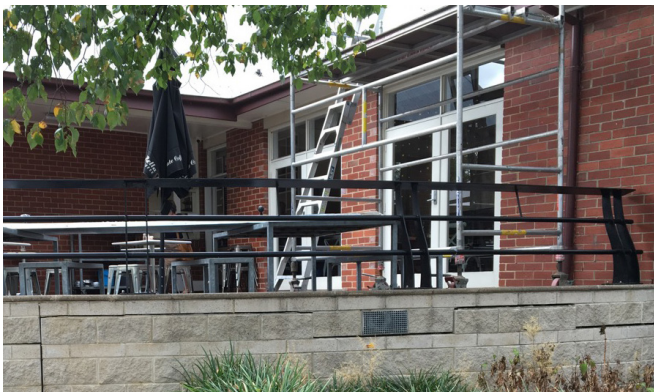
Mainmark's non invasive set up, allowing minimal disruption to the café

Mainmark recommended its Teretek® resin injection solution, utilising their deep-lift application method. This process involves the injection of engineered structural resins beneath sunken sections of the affected structure, filling any voids encountered to

Mainmark applied Teretek resin through very precise injection points along the length of the building foundation and footings on both the building and the courtyard retaining wall - a total distance of approximately 14 lineal metres - and to a depth of between 1.5m and 2m below ground level. This successfully raised the lowest corner of the building by 30mm from a measured settlement of 45mm. The courtyard retaining wall was also lifted 2-3mm, re-aligning it with the pavement slab.
